Case Report

Transdiscal Cement Leakage During Vertebroplasty

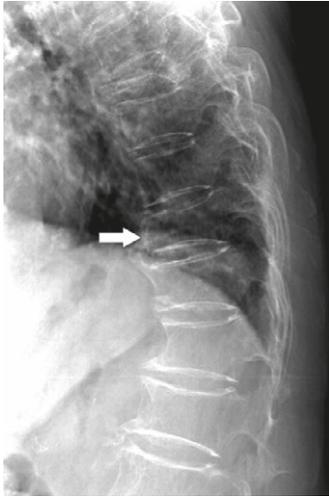
Fig. 1 — Lateral plain radiography of the thoracolumbar spine shows degenerative changes and a T10 compression fracture (arrow) with mild kyphotic changes. Relatively mild, chronic compression fractures at the T11 and T12 vertebrae can also be observed.

Plain radiographs taken in the outpatient department showed degenerative changes in the thoracolumbar spine and a compression fracture of thoracic vertebra 10 (T10) (Fig. 1). MRI showed T9 and T10 vertebrae fractures with poor healing (Fig. 2).

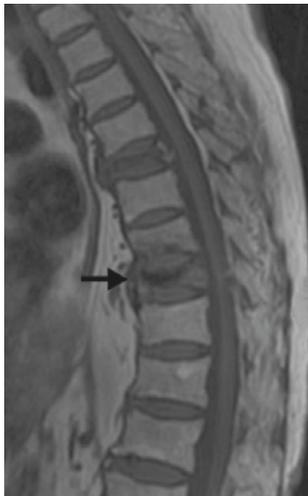
Fig. 2 — Sagittal T1-weighted magnetic resonance imaging (TR/TE: 600/8.5) of the thoracic spine shows T9 and T10 vertebrae compression fractures with poor healing and possible dead bone or air collection (arrow). A flat T7 vertebra due to an old fracture is also noted.

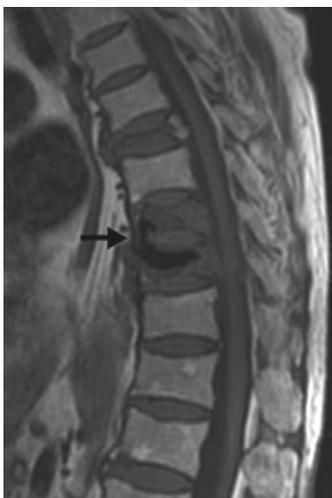
Fig. 5 — Sagittal T1-weighted magnetic resonance imaging (TR/TE: 400/8.5) shows dark cement in the T9 and T10 vertebral bodies, connected in the right anterior area (arrow).

that the bone cement did not leak into the spinal cavity or surrounding veins. We injected 4.3 mL bone cement into T10 and injected 2.5 mL bone cement into T9 until the cavity was filled. The patient could walk with the help of a walker the day after surgery. Abdominal and back pain was alleviated 3 days after surgery. The patient was discharged 4 days after surgery and was followed-up in the outpatient department (Figs. 4 and 5).

In summary, we encountered a case of extremely unusual transdiscal bone cement leakage in a 78-year-old woman. We have had no experience with this complication and could find no similar cases in the literature. Intraoperative observation and postoperative MRI confirmed that the bone cement leaked via the right anterior space below the anterior longitudinal ligament (Figs. 3 and 5). Good fluoroscopic equipment and experienced surgeons were the keys to the success of this surgery.
